**U.S. ENVIRONMENTAL PROTECTION AGENCY
POLLUTION/SITUATION REPORT
2015 Gold King Mine Release SITREP**

Subject: Situation Report #10
Gold King Mine Release
San Juan County, CO
Latitude: 37.8945 Longitude: -107.6384

Date: 08/18/2015

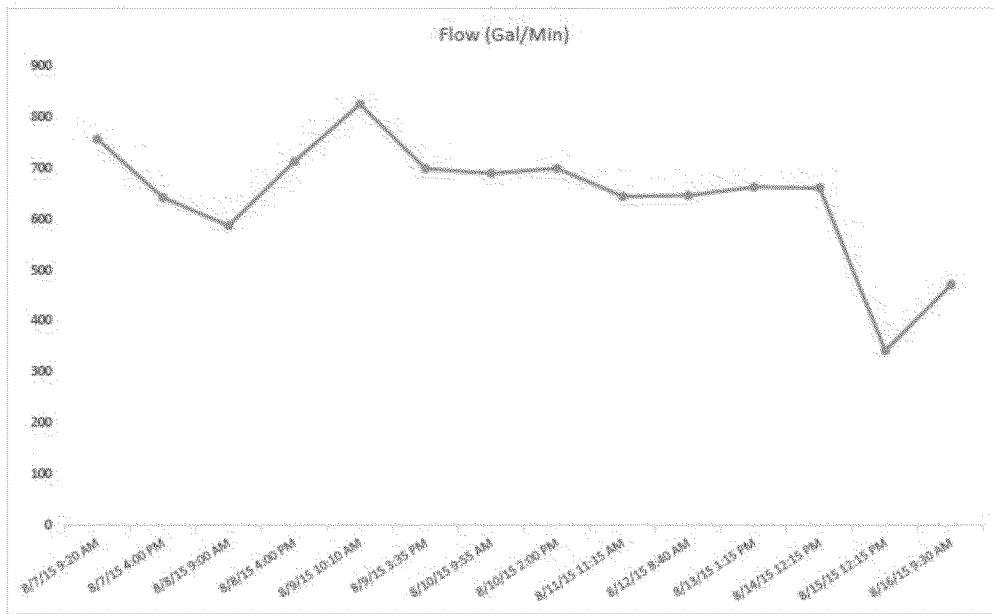
Flow from the mine through the morning of 8/16/2015 is shown in the following chart. **The flow at hour 1500 was 544 gallons per minute (gpm).** Treated water from the last treatment pond is discharging into Cement Creek. **The graph will be updated in the next SITREP.**
